Performance Assessment of Taunsa Barrage Subsidiary Weir for Long Term Rehabilitation Planning

Abstract

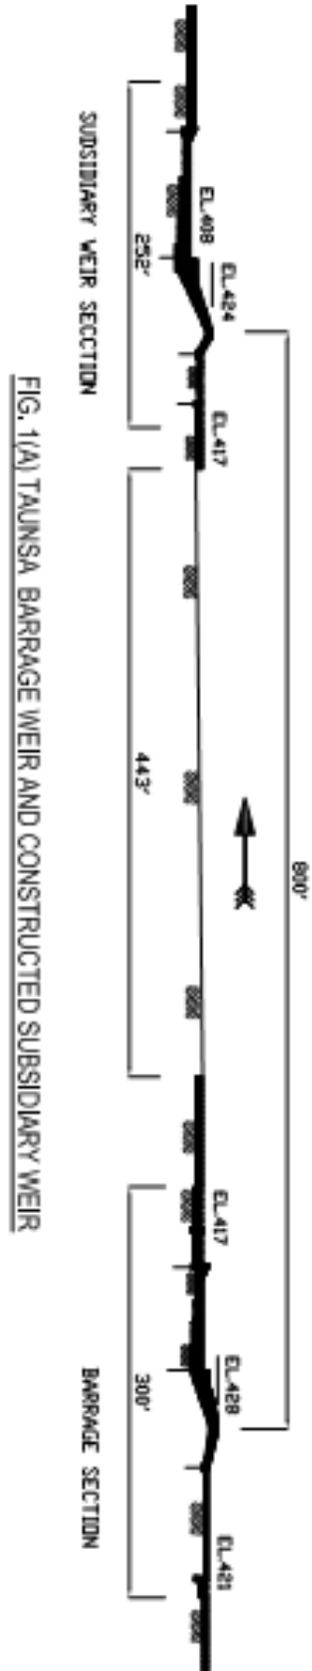
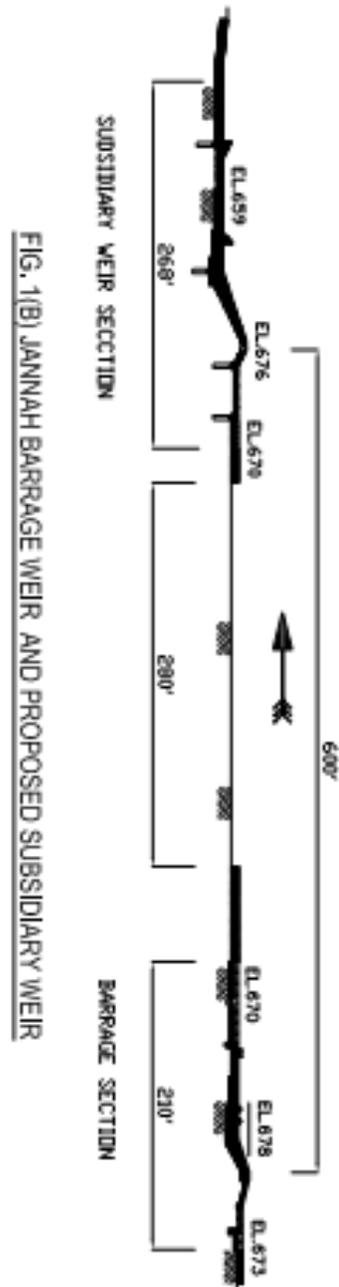
Fig. 1 Long section of Taunsa and Jinnah Barrages and subsidiary weirs

Taunsa barrage consists of 53 weir bays; whereas left and right undersluices are having 7 and 4 bays, respectively. The barrage width between abutments is 4346 ft and clear water waterway is 3862 ft. Two divide walls bifurcates weir and undersluices sections of the barrage. In left and right undersluices, along the divide walls two fish ladders are provided. Taunsa barrage has 22 ft wide navigation bay and silt exclusion system in its right and left undersluices, respectively. The barrage is designed for a flood of 1,000,000 cusec; however a super flood of 1,200,000 cusec may pass without endangering the barrage. It is mentioned earlier that a subsidiary weir has been constructed downstream of the barrage to raise tail water level (Figure 1(a)).

left and right undersluices, two fish ladders are provided along the divide walls. The design discharge of this barrage is 950,000 cusec; however a super flood of 1,100,000 cusec may be passed through the barrage. It is earlier mentioned that to raise tail water level, a subsidiary weir has been proposed at 600 ft distance from the barrage crest (Figure 1(b)).

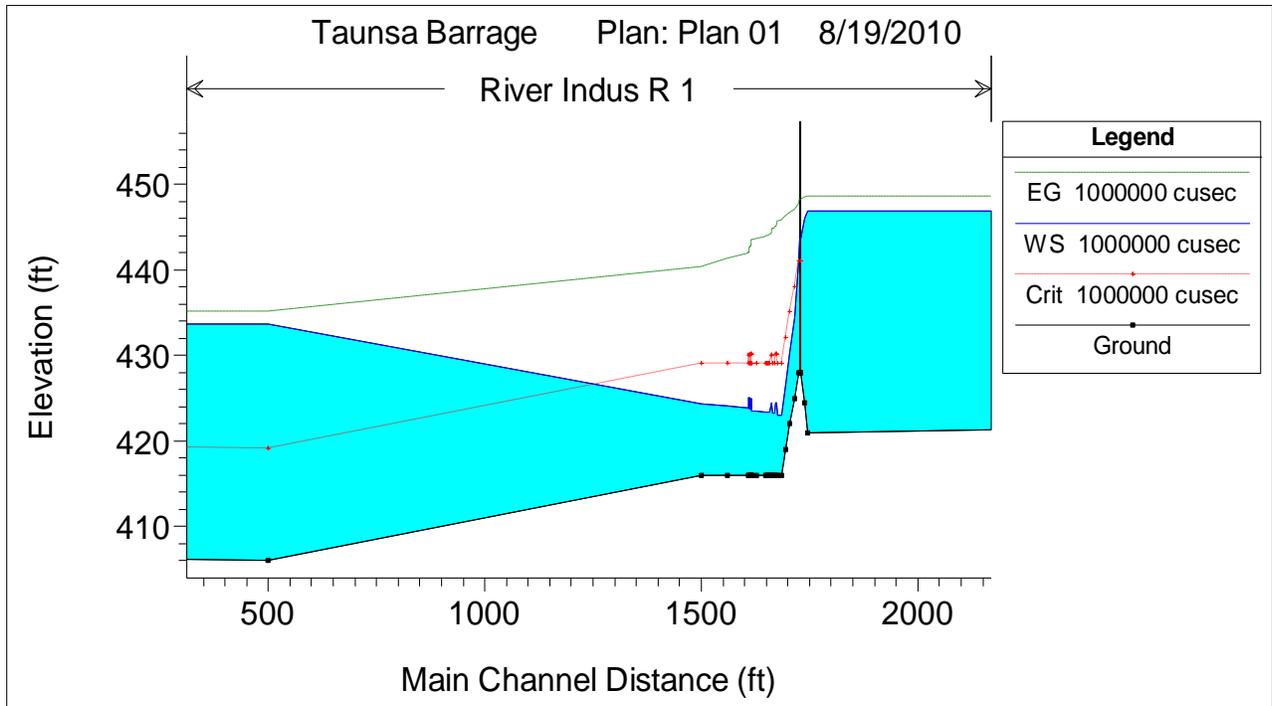
Fig. 2 Profiles at the discharge of 1000000 cusec, (Tail water level EL 433.40)

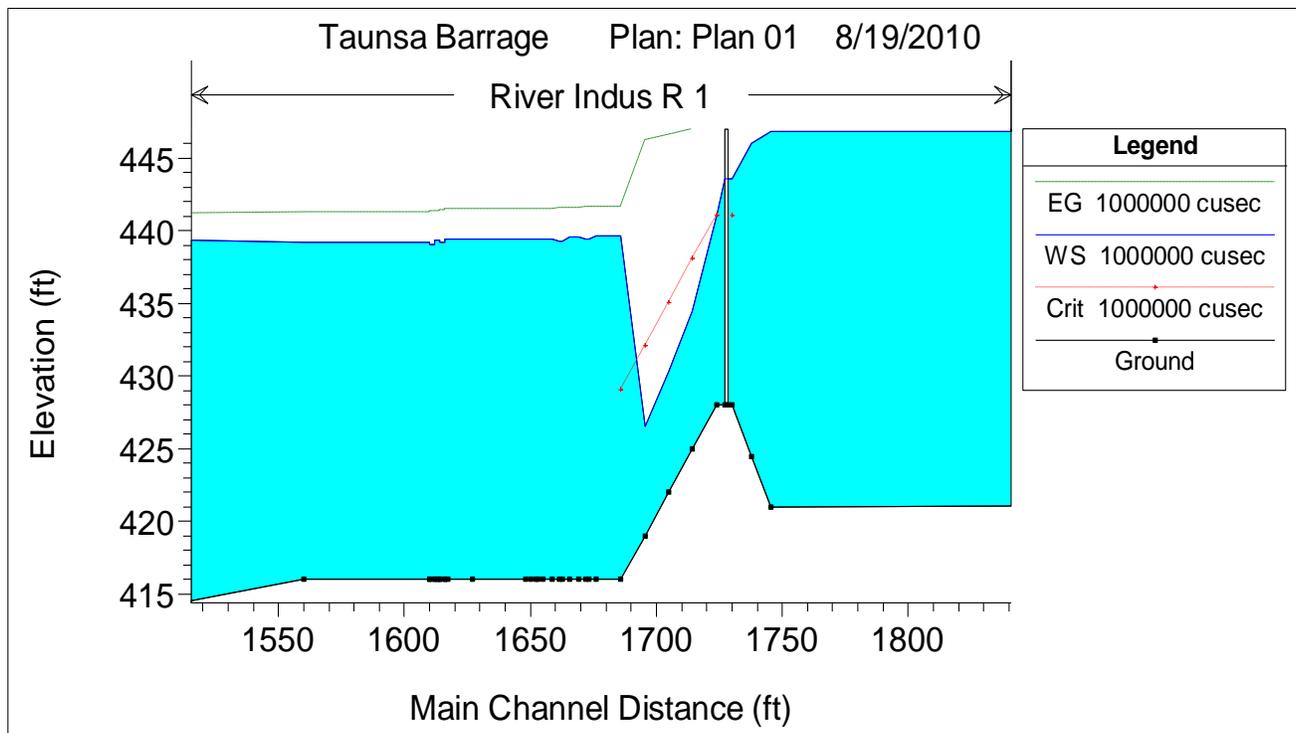
Fig. 3 Profiles at the discharge of 1000000 cusec, (Tail water level EL 439.50)
